**East Chisenbury Fly Fishing Club**  
**River restoration report.**  
**Part II – Installation and Post-restoration appraisal**

**Introduction:** This report follows on from the part I case study download which covers the background and design elements of this project..

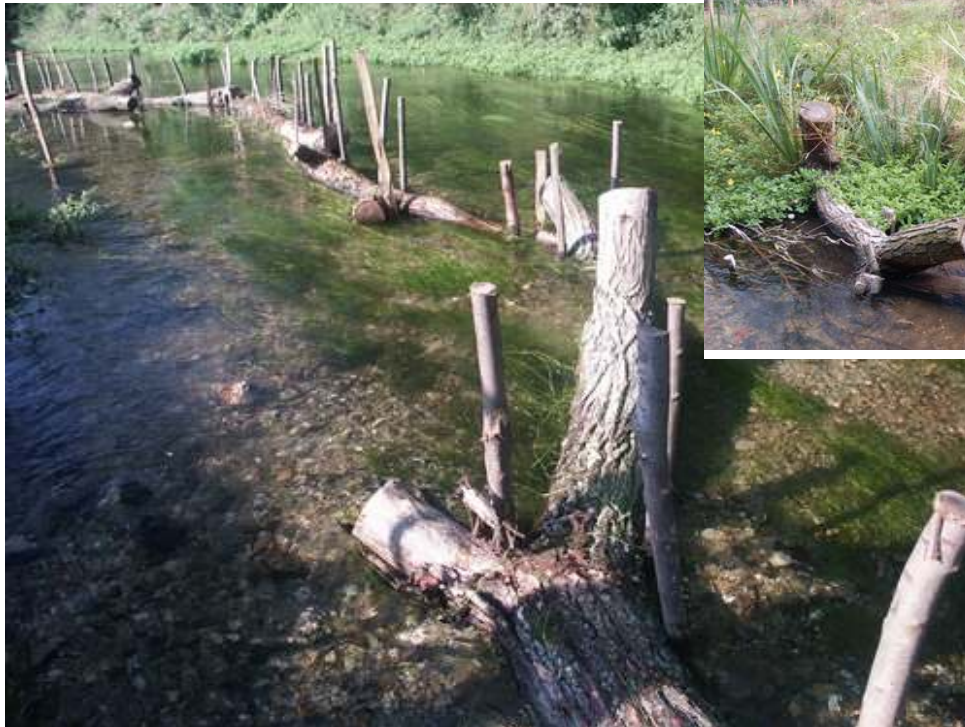
**Fig.7** Mark out the line of the new bank face ‘toe’ using carefully selected woody material, where available. This can be live or dead depending on need and is not species critical.

Bearing in mind that channel narrowing and re-alignment works positively effect water depths and flow speeds, these ‘soon-to-be-submerged’ logs will provide a vital niche substrate for various invertebrates and aquatic plant species such as ‘olive’ nymphs (*Baetis* spp.) freshwater shrimp (*Gammarus* spp) , Willow Moss (*Fontinalis* spp) and Starwort (*Callitriche* spp). LWD also provides an essential spawning substrate for various coarse fish species and and egg-laying sites for terrestrial insects with an aquatic larval stage. For this reason and in order to assist the life cycle of up-winged flies, it is important to ensure that emergent ‘spurs’ are left protruding above average summer water levels at regular intervals as indicated above. (Nb. These spurs are identified ‘A’ & ‘B’ in Figs 7 & 8)

above. The dotted line in Fig 7 shows the alignment of the 'soon-to-be installed 'coirnet' bank access will be re-identified later in the post-restoration appraisal.)

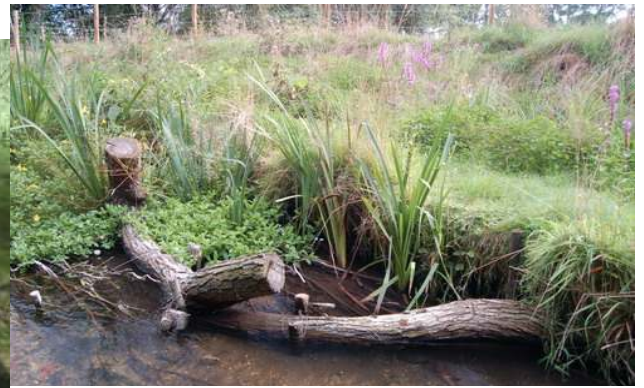
**Fig.7a** (above) The same structure 12 months later. This illustrates the way in which protruding sections of LWD & CWD can be combined with coirnet access banks to create sustainable marginal habitats.

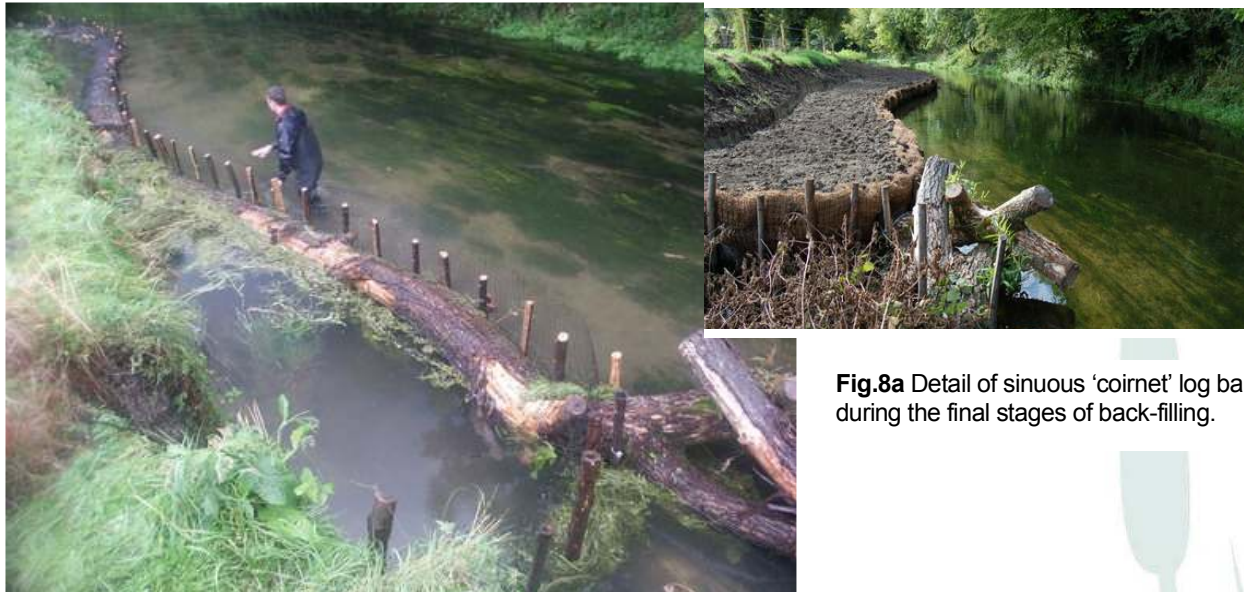
**Fig.8a** Detail of sinuous 'coirnet' log bank during the final stages of back-filling.

**Fig.8** Sinuosity can be achieved by the careful selection of on-site woody material.

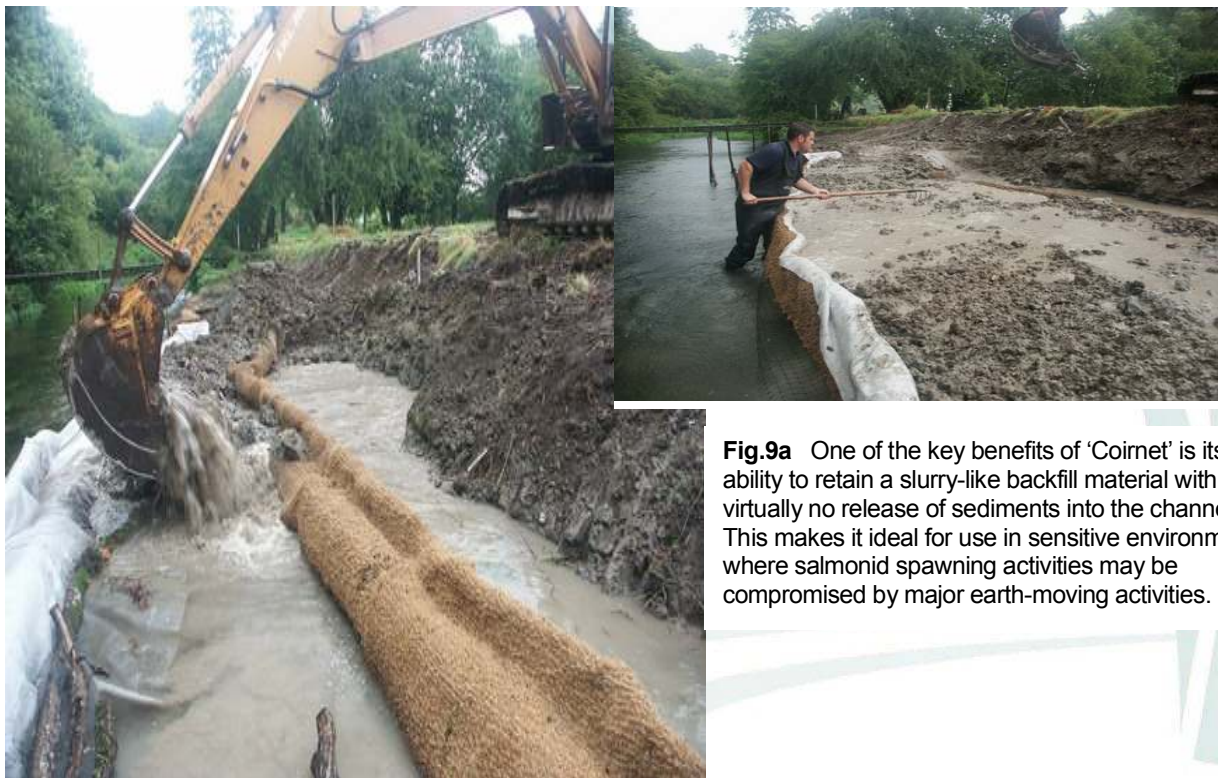
**Fig.9a** One of the key benefits of 'Coirnet' is its ability to retain a slurry-like backfill material with virtually no release of sediments into the channel. This makes it ideal for use in sensitive environments where salmonid spawning activities may be compromised by major earth-moving activities.

**Fig.9** CBE's 'Coirnet' bank revetments being in-filled to form a new low-level riparian flood berm. The borrow pit being excavated to the rear will be retained as an off-line pond.

The soil-retaining capacity of the new bank is achieved by the use of a multi-ply 'Coirnet' product developed 'in-house' by CBE Ltd. This was developed to deliver sustainability in a variety of fluvial environments where traditional soft engineering techniques on their own, have only proved effective in the short to medium term.

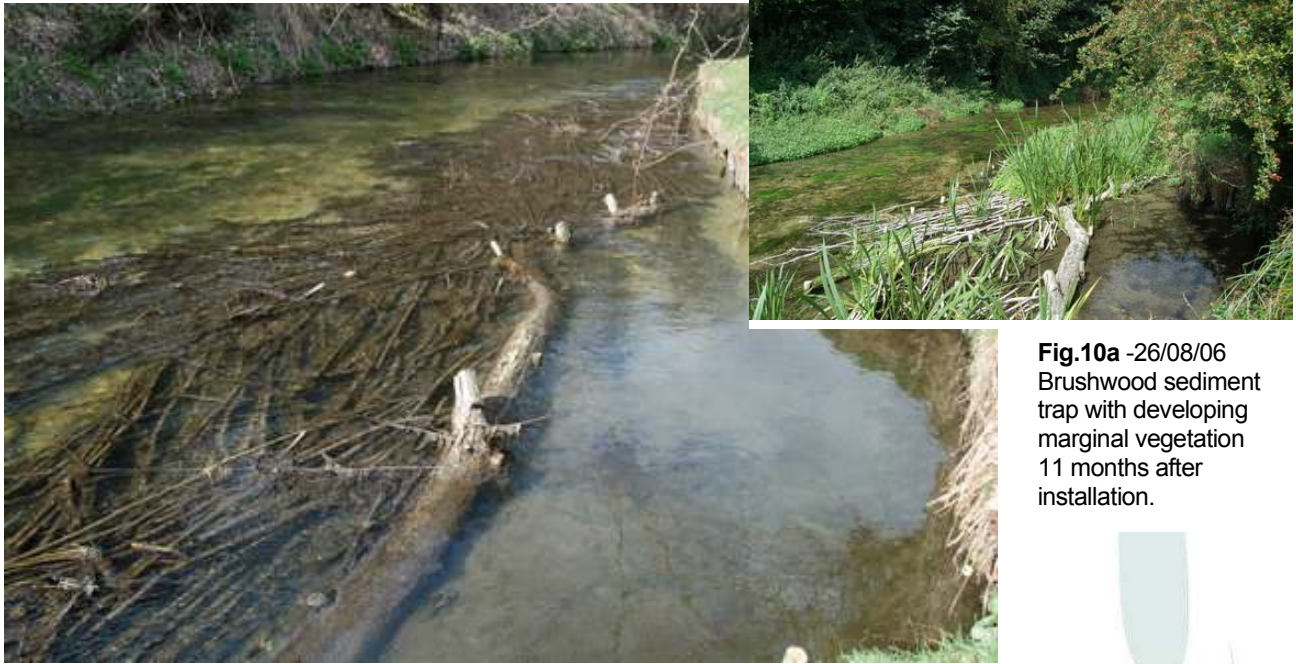
**Fig.10a** -26/08/06  
Brushwood sediment trap with developing marginal vegetation 11 months after installation.

**Fig.10 26-03-06 Spring 2006** Brushwood marginal mattress with light organic sediment accretions 6 months after installation. The anticipated heavy inorganic accretions failed to materialise due to a drought winter and almost total lack of floods.

The emergent plants (*Butomus*, *Sparganium*, *Iris*) seen in fig 10a above are now buried in up to 600mm deep of accreted material. Some of them are now starting to emerge through the deposits (fig 10c) and are expected to rapidly colonise the entire area by October 2007.

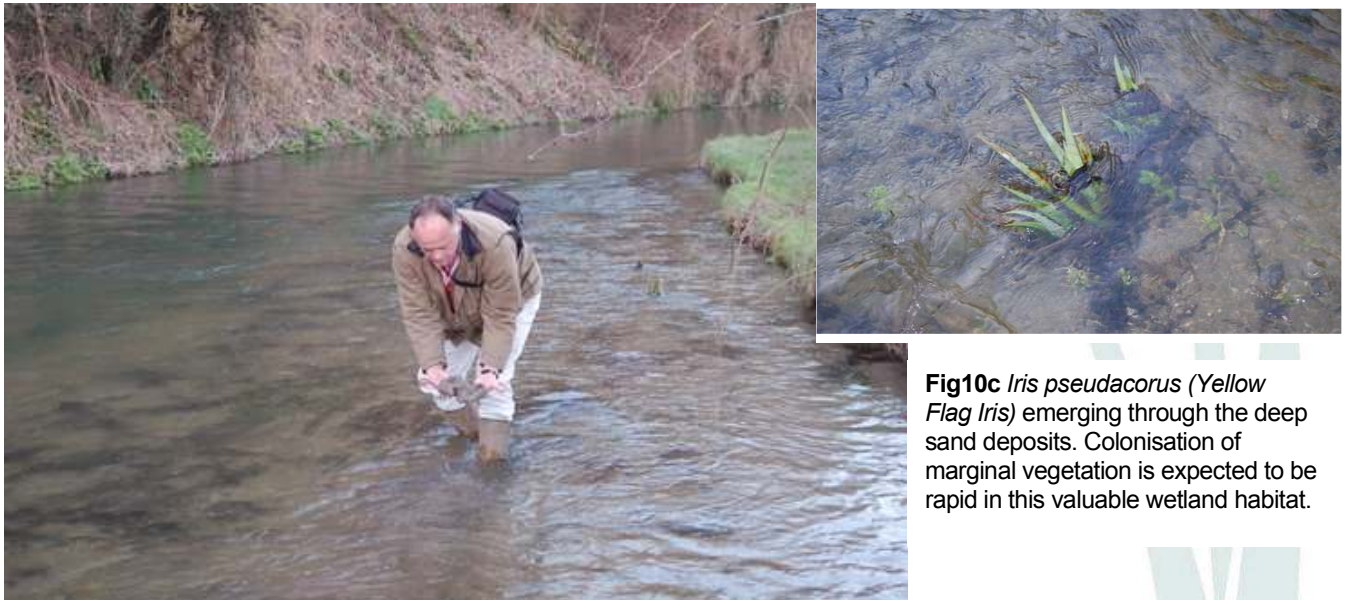
**Fig10c** *Iris pseudacorus* (Yellow Flag Iris) emerging through the deep sand deposits. Colonisation of marginal vegetation is expected to be rapid in this valuable wetland habitat.

**Fig.10b – 03/02/07** - The brushwood sediment trap has now accreted substantially with fine inorganic sand following a succession of winter flood events.

At the time of writing, (26/02/07) yet another flood has over-topped the berm (seen right of shot in fig 10b), and sediment is still accreting onto the main marginal mattress area. The expectation is that the upper sand level seen above will be emergent when the high winter flows recede back to normal summer levels.

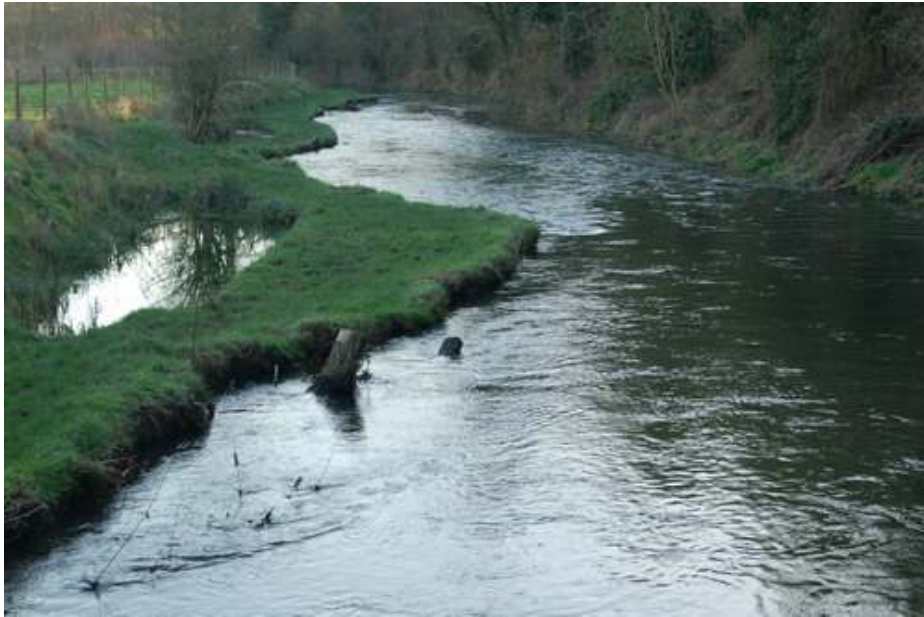
- **Fig.11** re-introduce variation to the rivers width

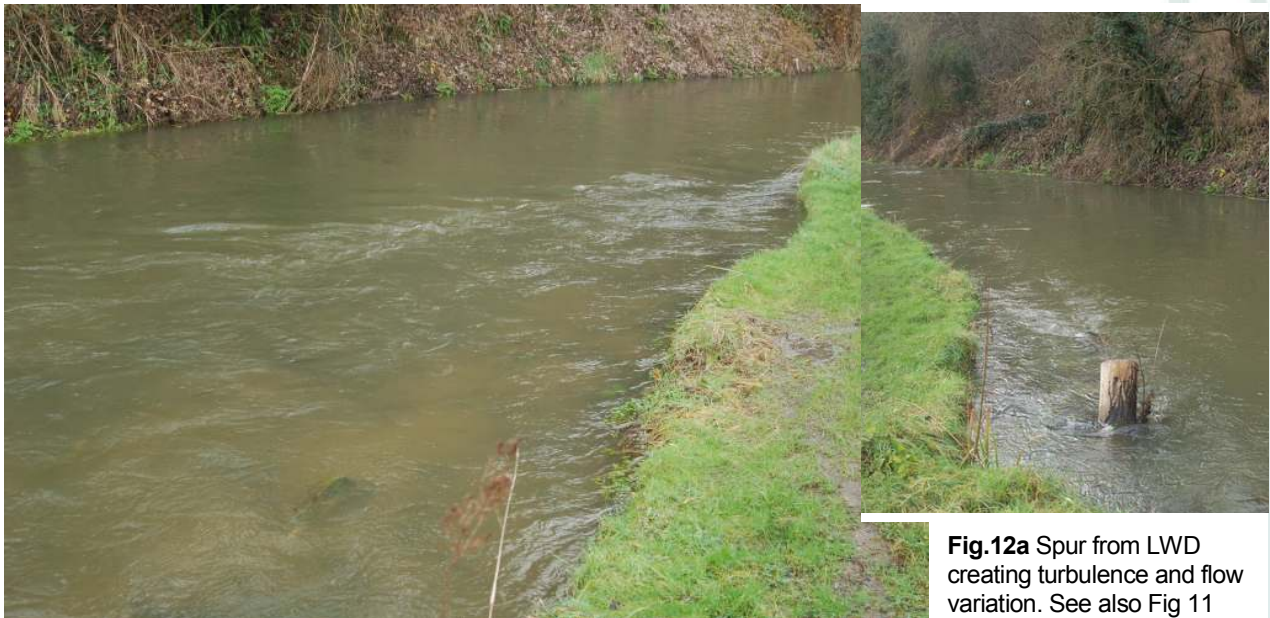
- **Fig.12** re-introduce variation to the flow types

**Fig.12a** Spur from LWD creating turbulence and flow variation. See also Fig 11 above. Flow variation influences substrate distribution and associated niches

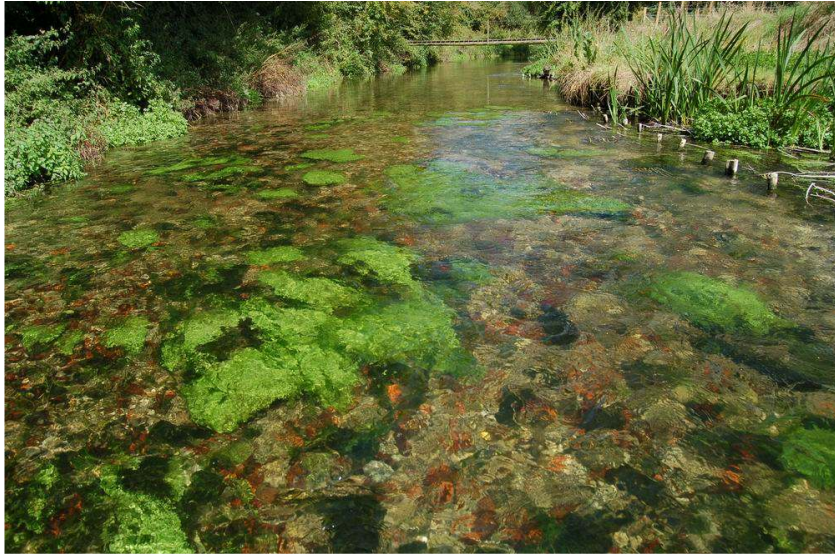
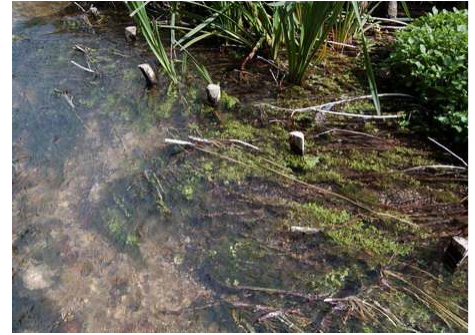
**Fig.13a** Detail of Fig 13 showing fine woody debris interface between the marginal mattress and scoured gravels. This is an excellent niche for *Gammarus* shrimp and Brook Lamprey *Lampetra*.

- **Fig.13** re-create hydro-morphological features compatible with BAP species habitat requirements.

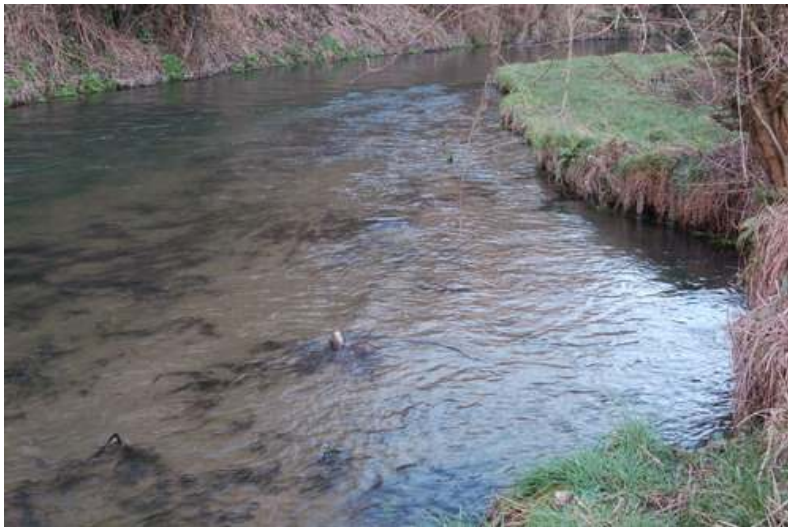
- **Fig.14** vary the substrate types and distribution at key locations within the channel

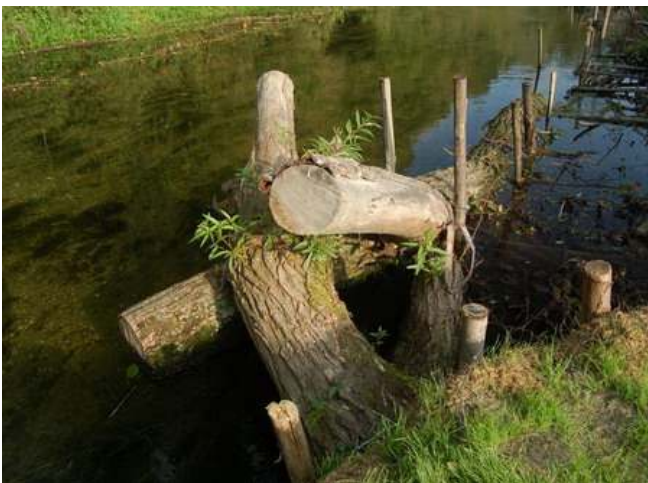
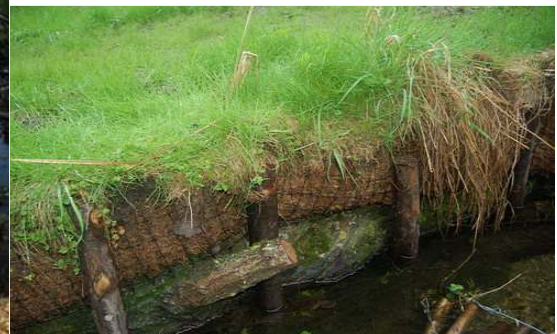
**Fig 15a** – Composite LWD/Coirnet Bank revetment.

- **Fig.15** incorporate coarse woody debris (CWD) & large woody debris (LWD) into the new banks and margins at key locations.

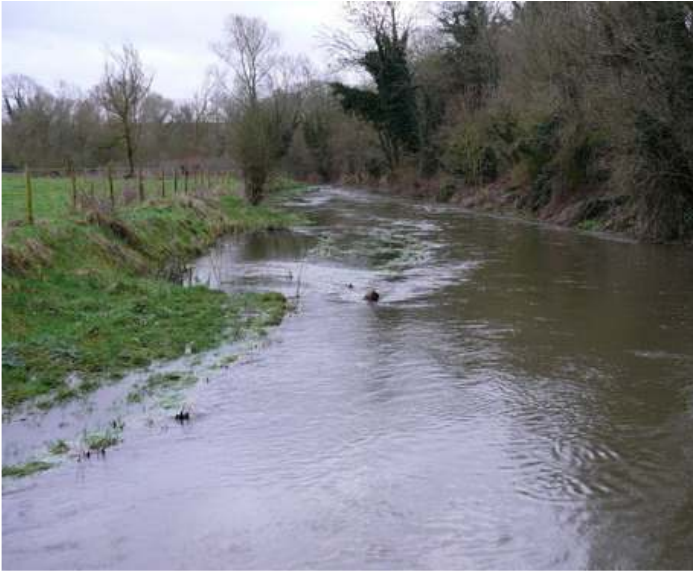
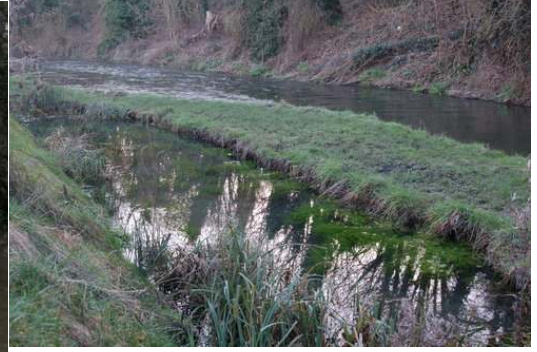
**Fig.16a** Marginal pond habitat in riparian zone.

- **Fig 16** - Create a sustainable, flood-friendly, bio-diverse riparian zone.
