ENVIRONMENT AGENCY

East Chisenbury river enhancement scheme Phase - I

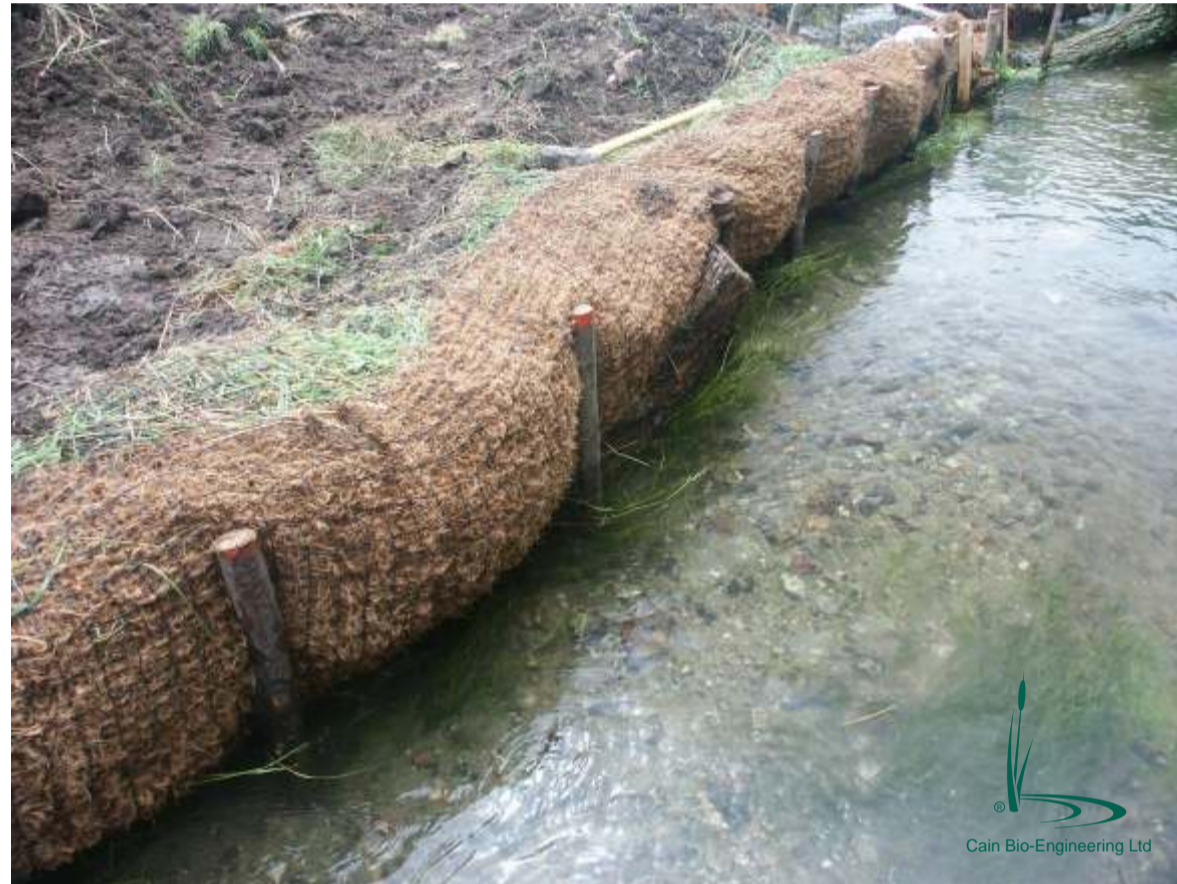
Coirnet bank revetment

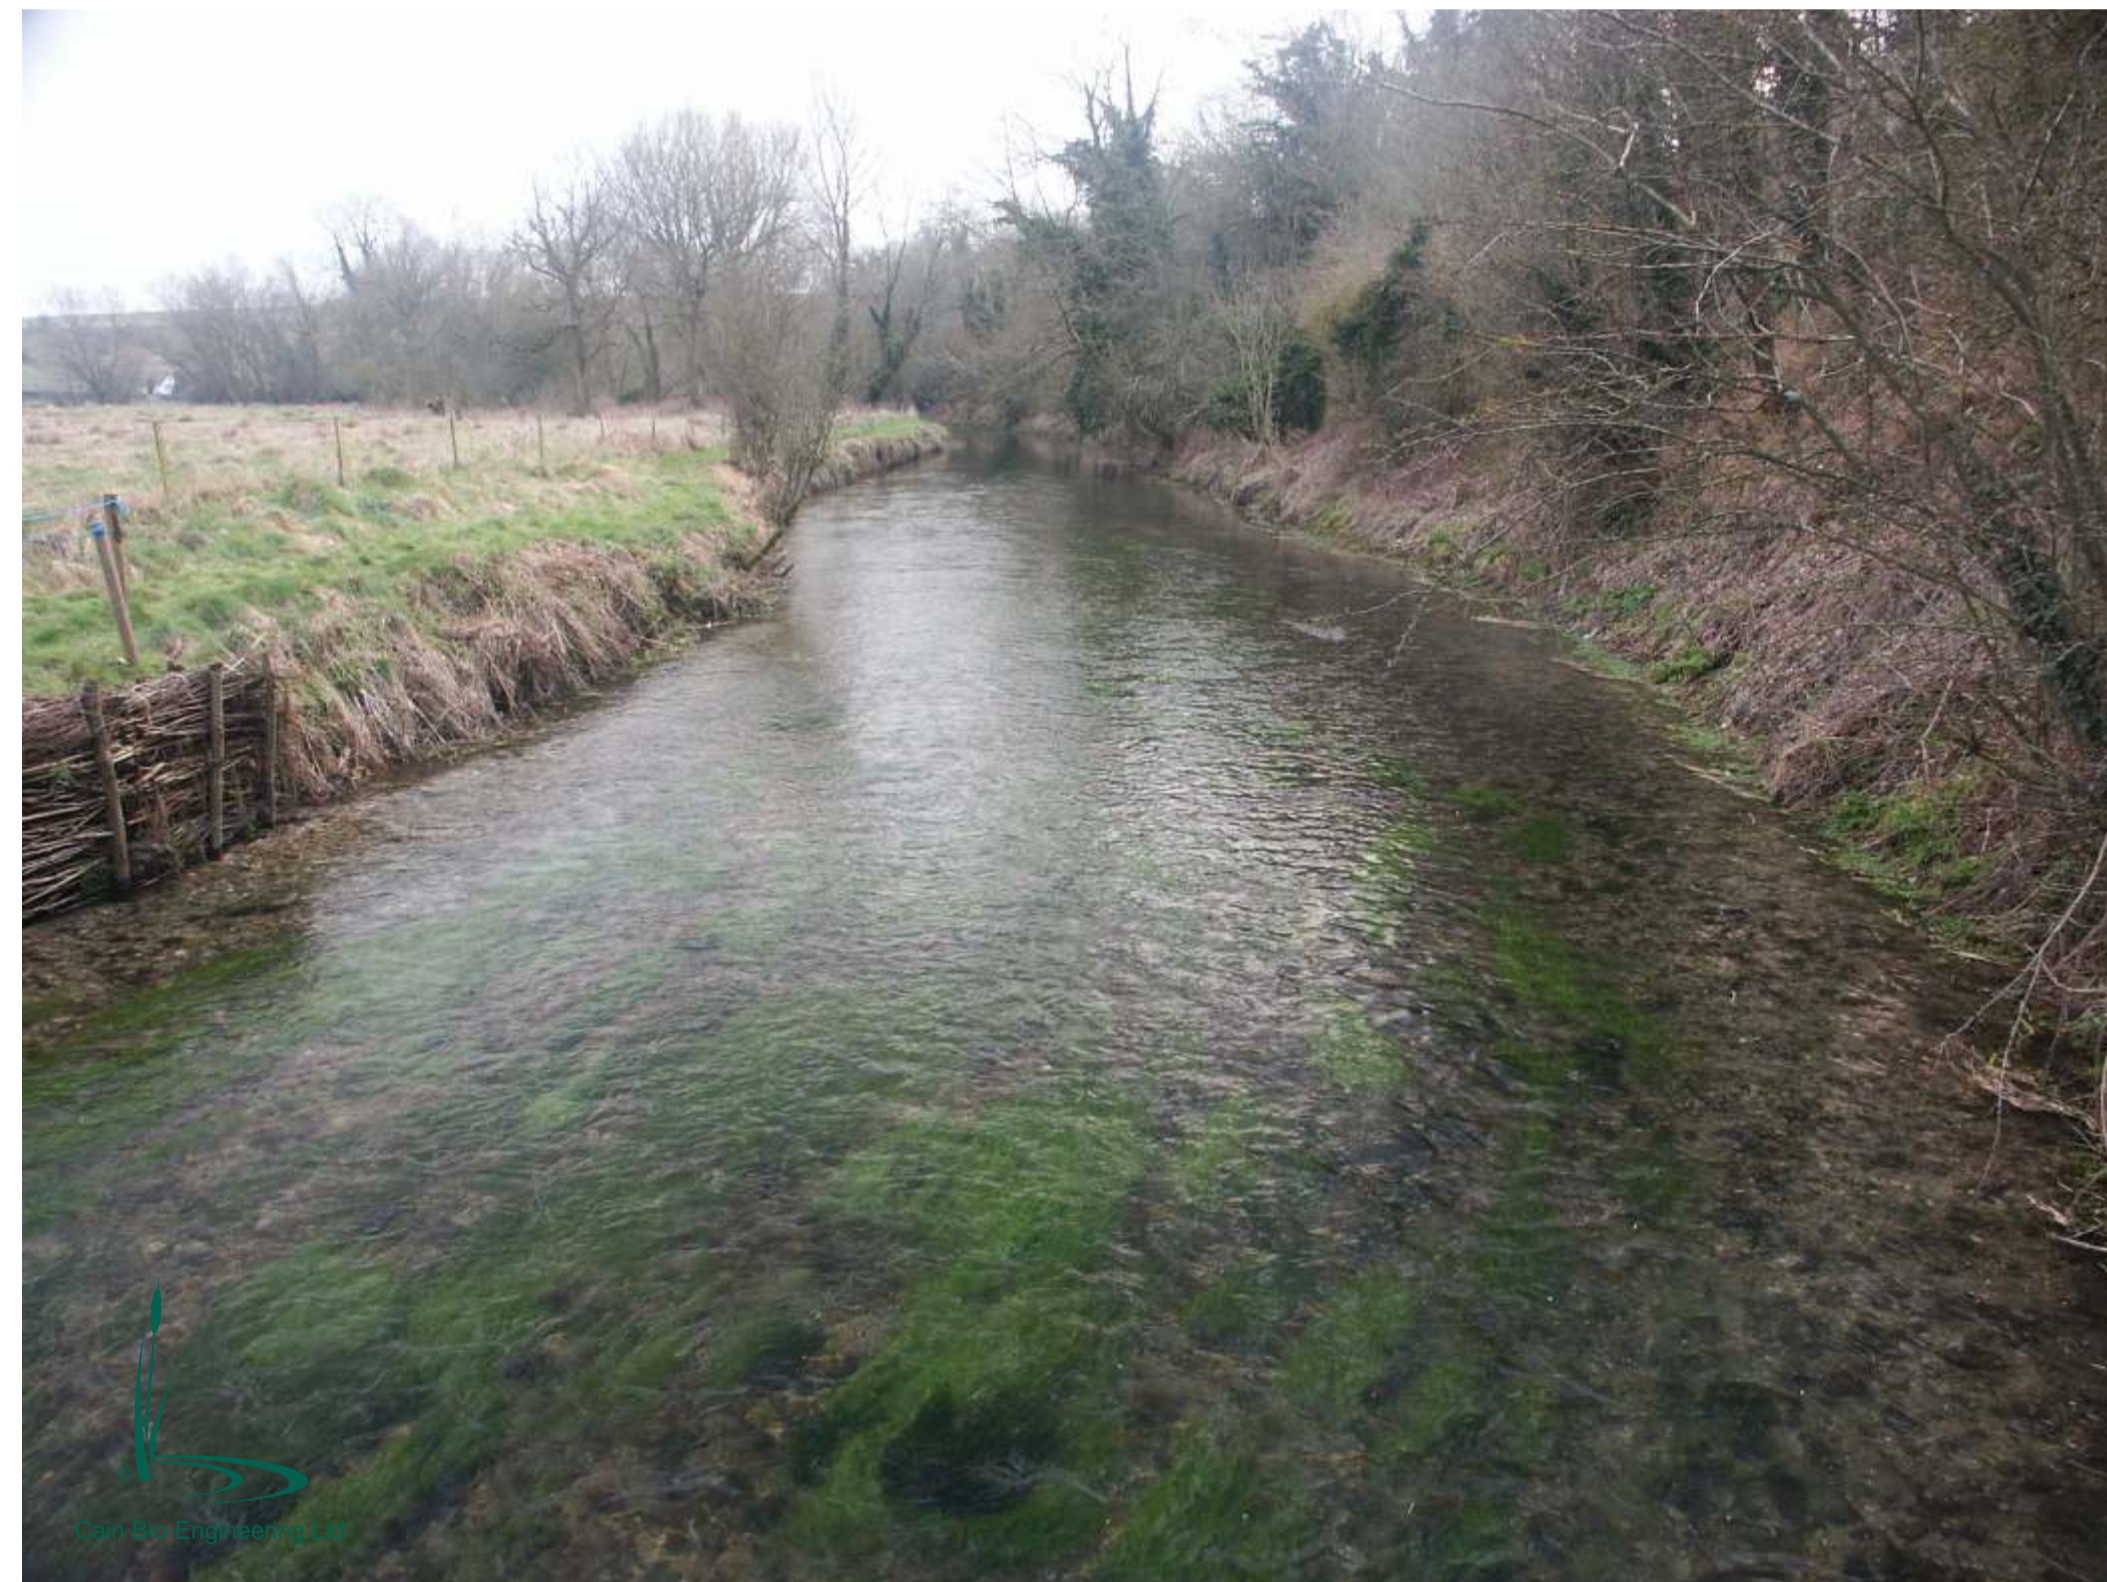
'BEFORE' - March 2005 - Showing over-widened, dredged channel

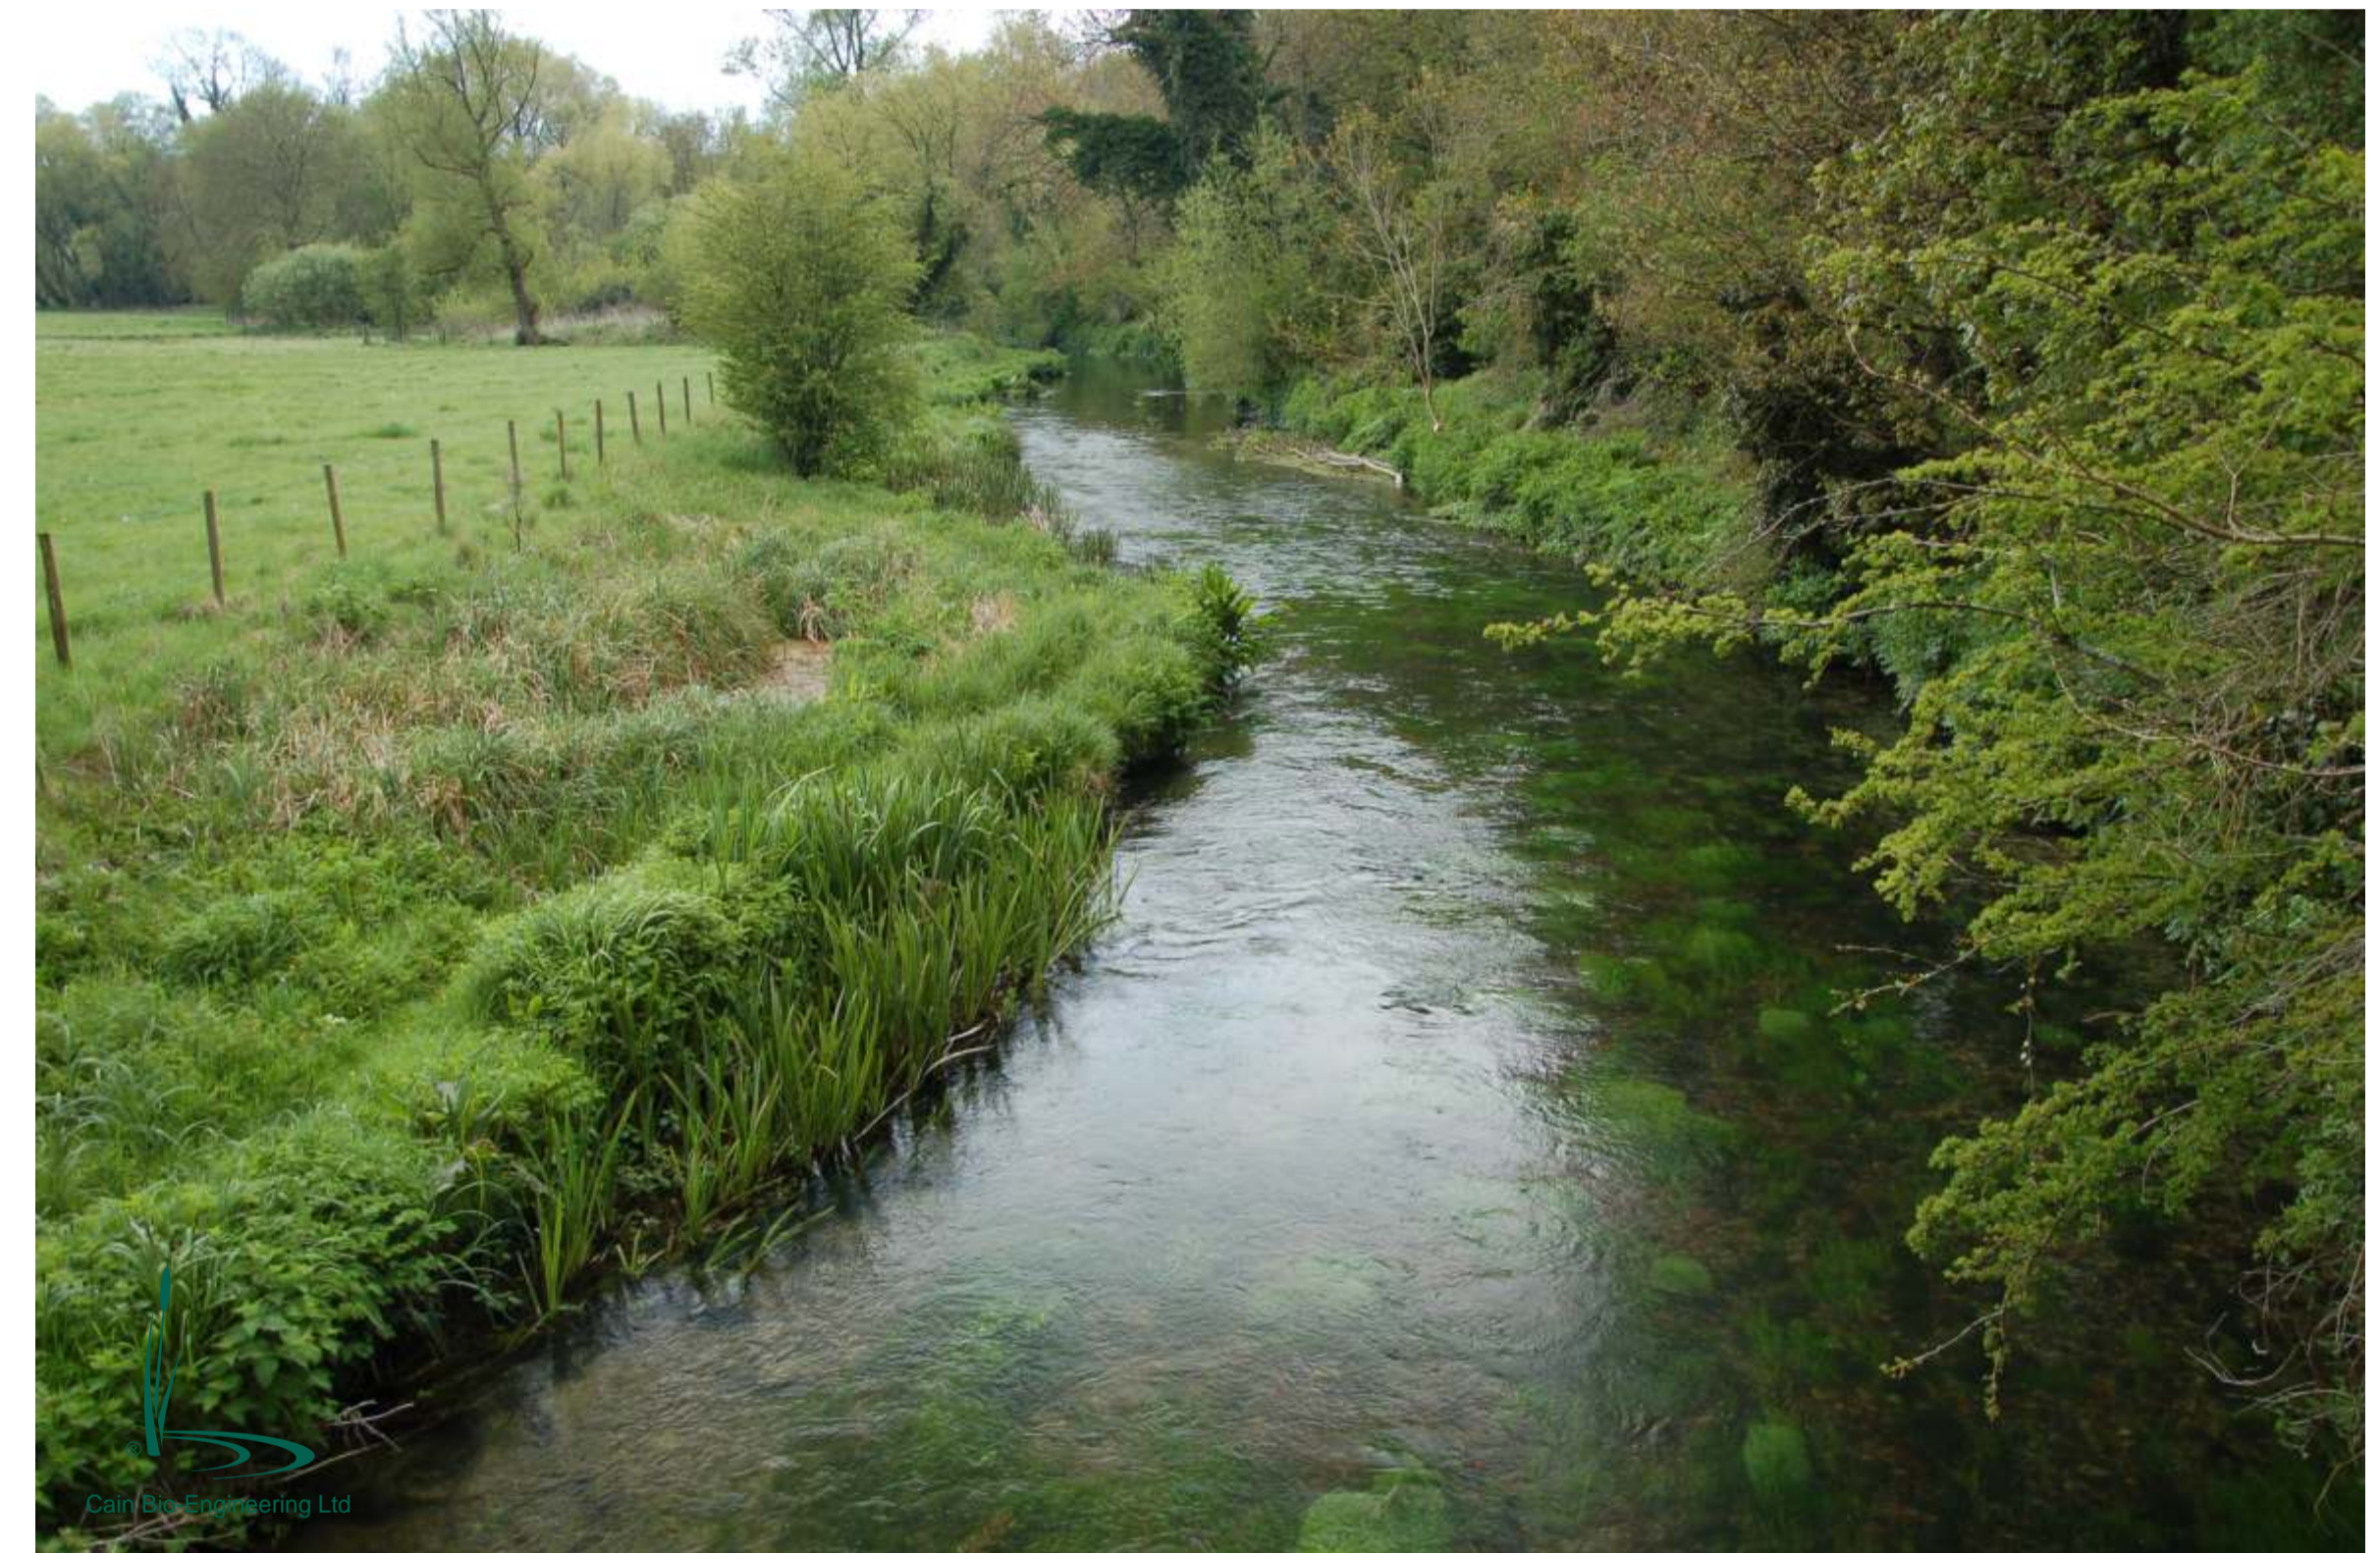
'AFTER' - May 2010 - Five years later showing 'favourable condition'

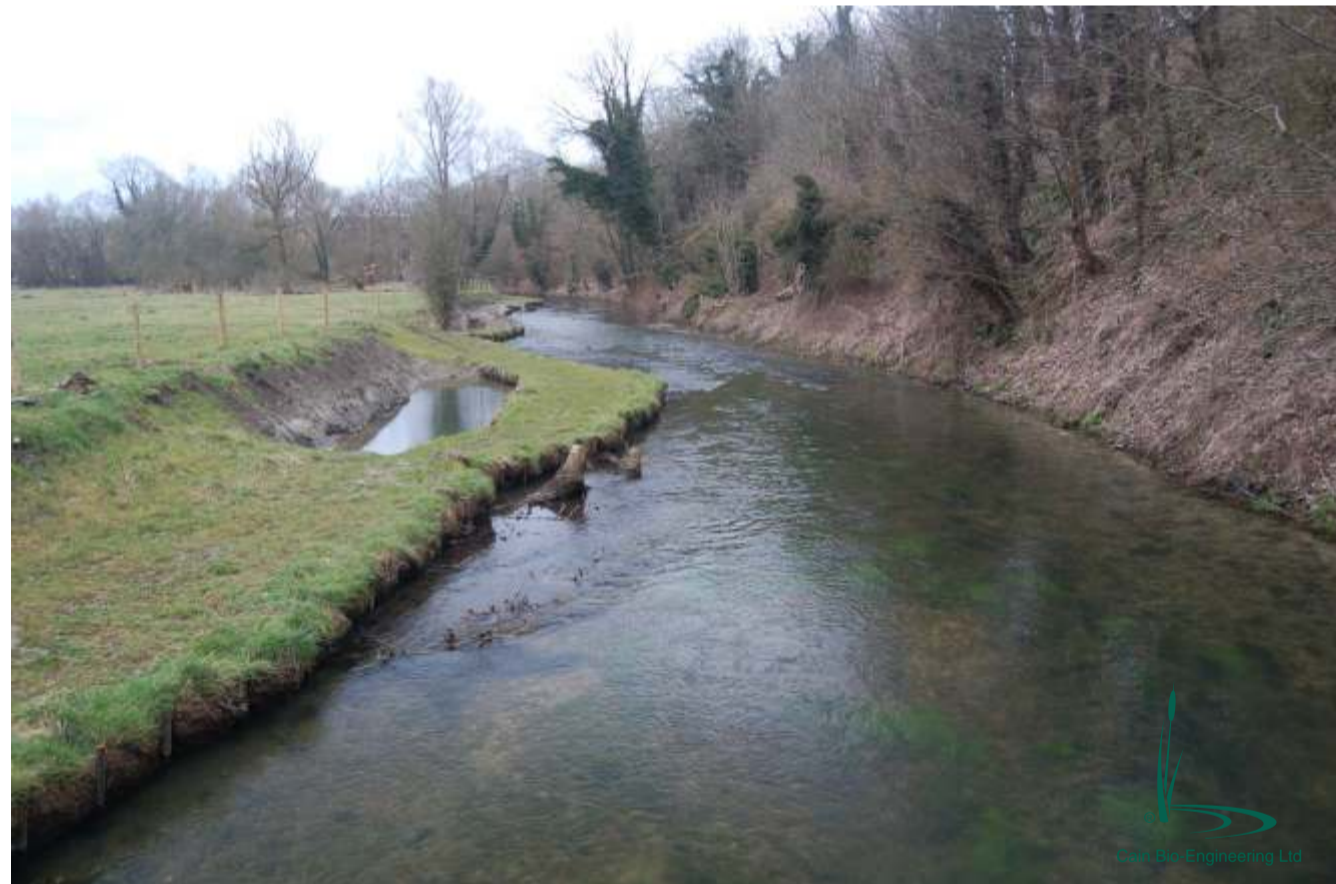
Sinuous flood berm with bio-diverse riparian zone

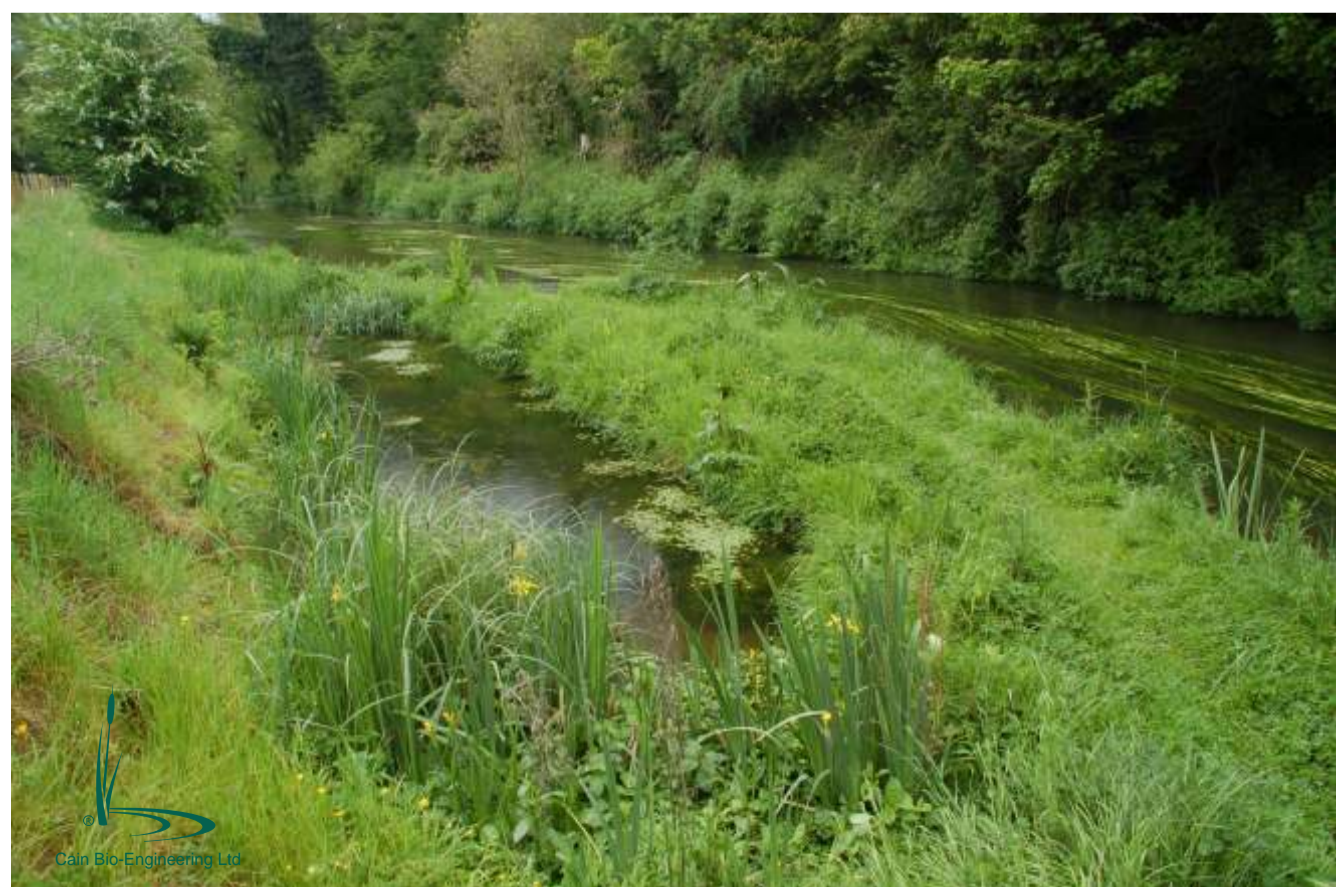
Riparian pond

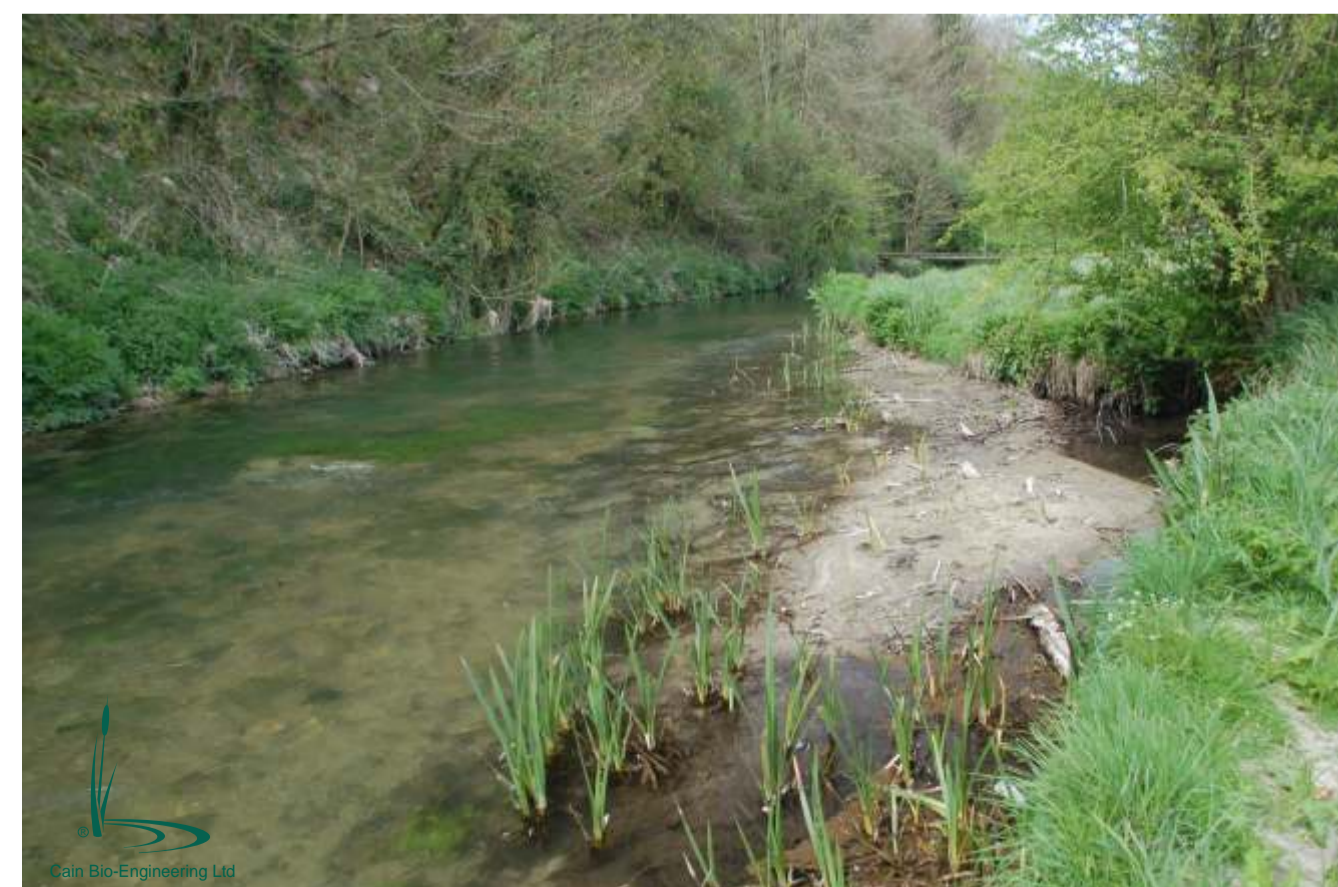
Brushwood sediment trap

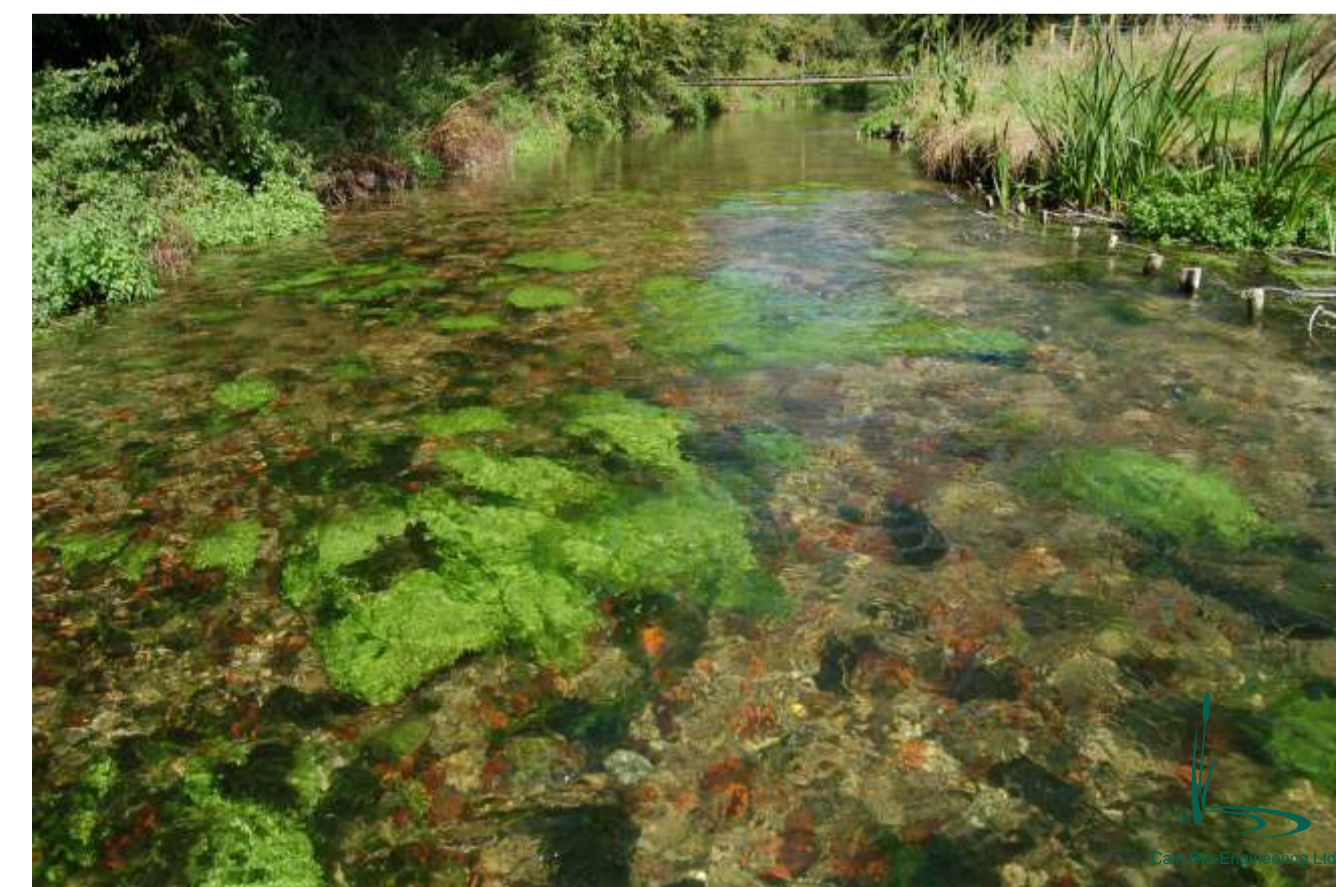
Spawning riffle - seen here during low flows

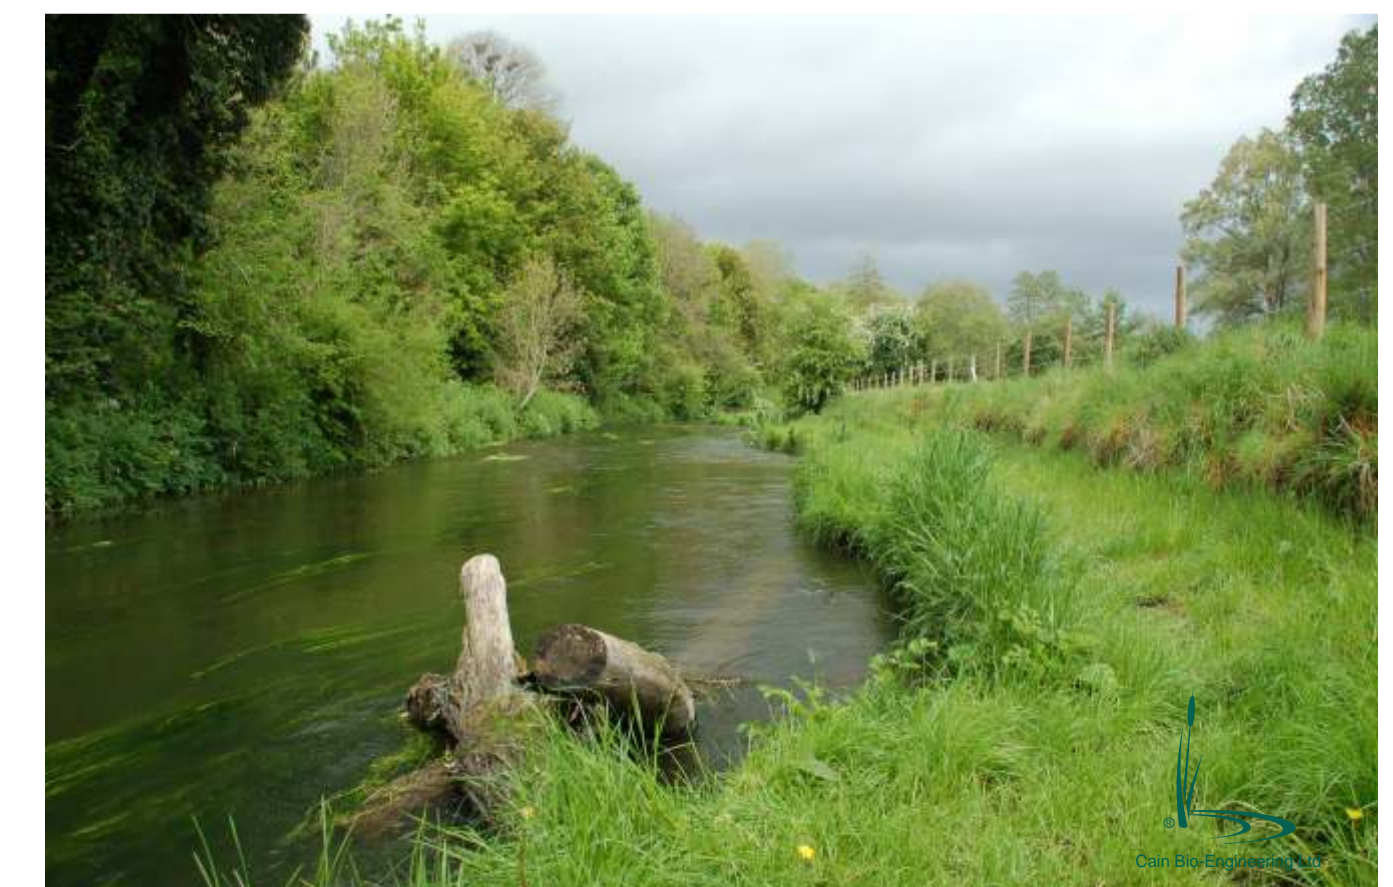
Composite Coirnet berm with LWD
